Manhole Inspection Summary

Manhole # S35QQ1002MH

Inspection ☐ Is Incomplete Rating: **4) Poor**

Location Address: **303 WINSTON AVE**

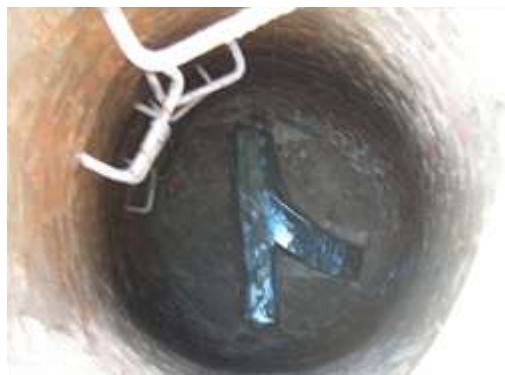
Top View

Evidence of surcharge - Bench debris.

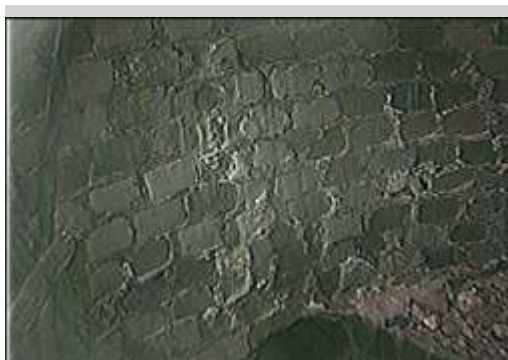
Defect

Barrel deterioration and infiltration.

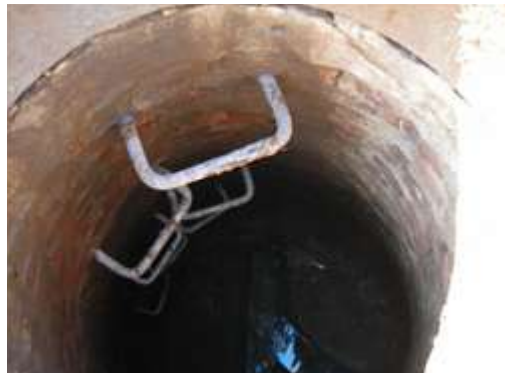
Defect

Frame leaks. Adjustment deterioration and infiltration. Corbel and Barrel infiltration - other side.

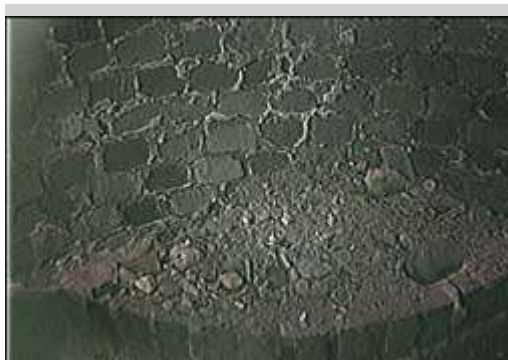
Defect

Barrel deterioration and infiltration.

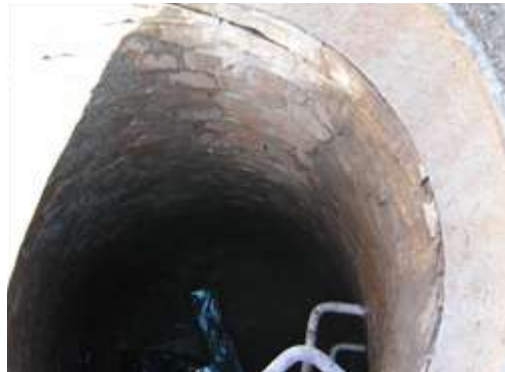
Defect

Frame leaks. Adjustment deterioration and infiltration. Corbel and Barrel infiltration.

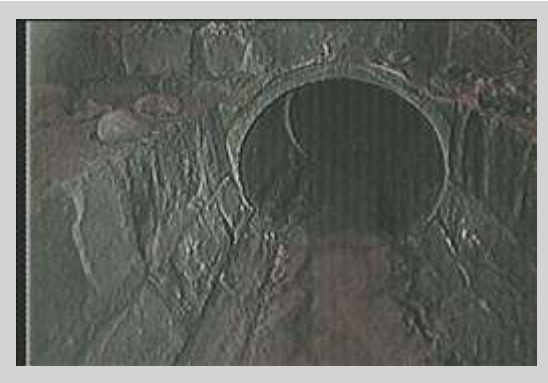
10 in. Circular Gravity Sewer Pipe Out @ 12 O'Clock

Channel deterioration.

Infiltration: **Evidence** Pipe Seal Cond: **Cracked**

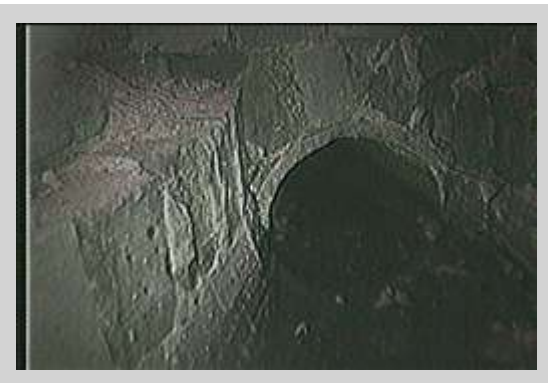
8 in. Circular Gravity Sewer Pipe In @ 4 O'Clock

Deposits: ☐ None ☒ **Mud** ☐ Sludge ☒ **Debris** ☐ Grease

Silt Depth: **0.5** (in.) Deposits Extent: **Light**

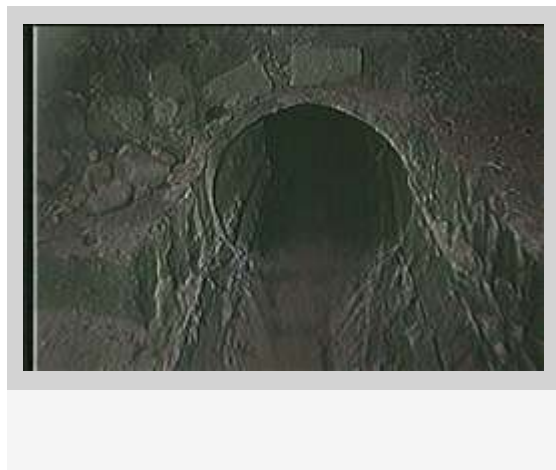
10 in. Circular Gravity Sewer

Infiltration: **Evidence**
